**PHASE I RECONNAISSANCE
SITE CHARACTERIZATION REPORT
FOR THE
SILVER CREEK DRAINAGE PROJECT**

Lewis & Clark County, Montana

**Olympus Technical Services, Inc.
765 Colleen
Helena, Montana 59601**

February 2003

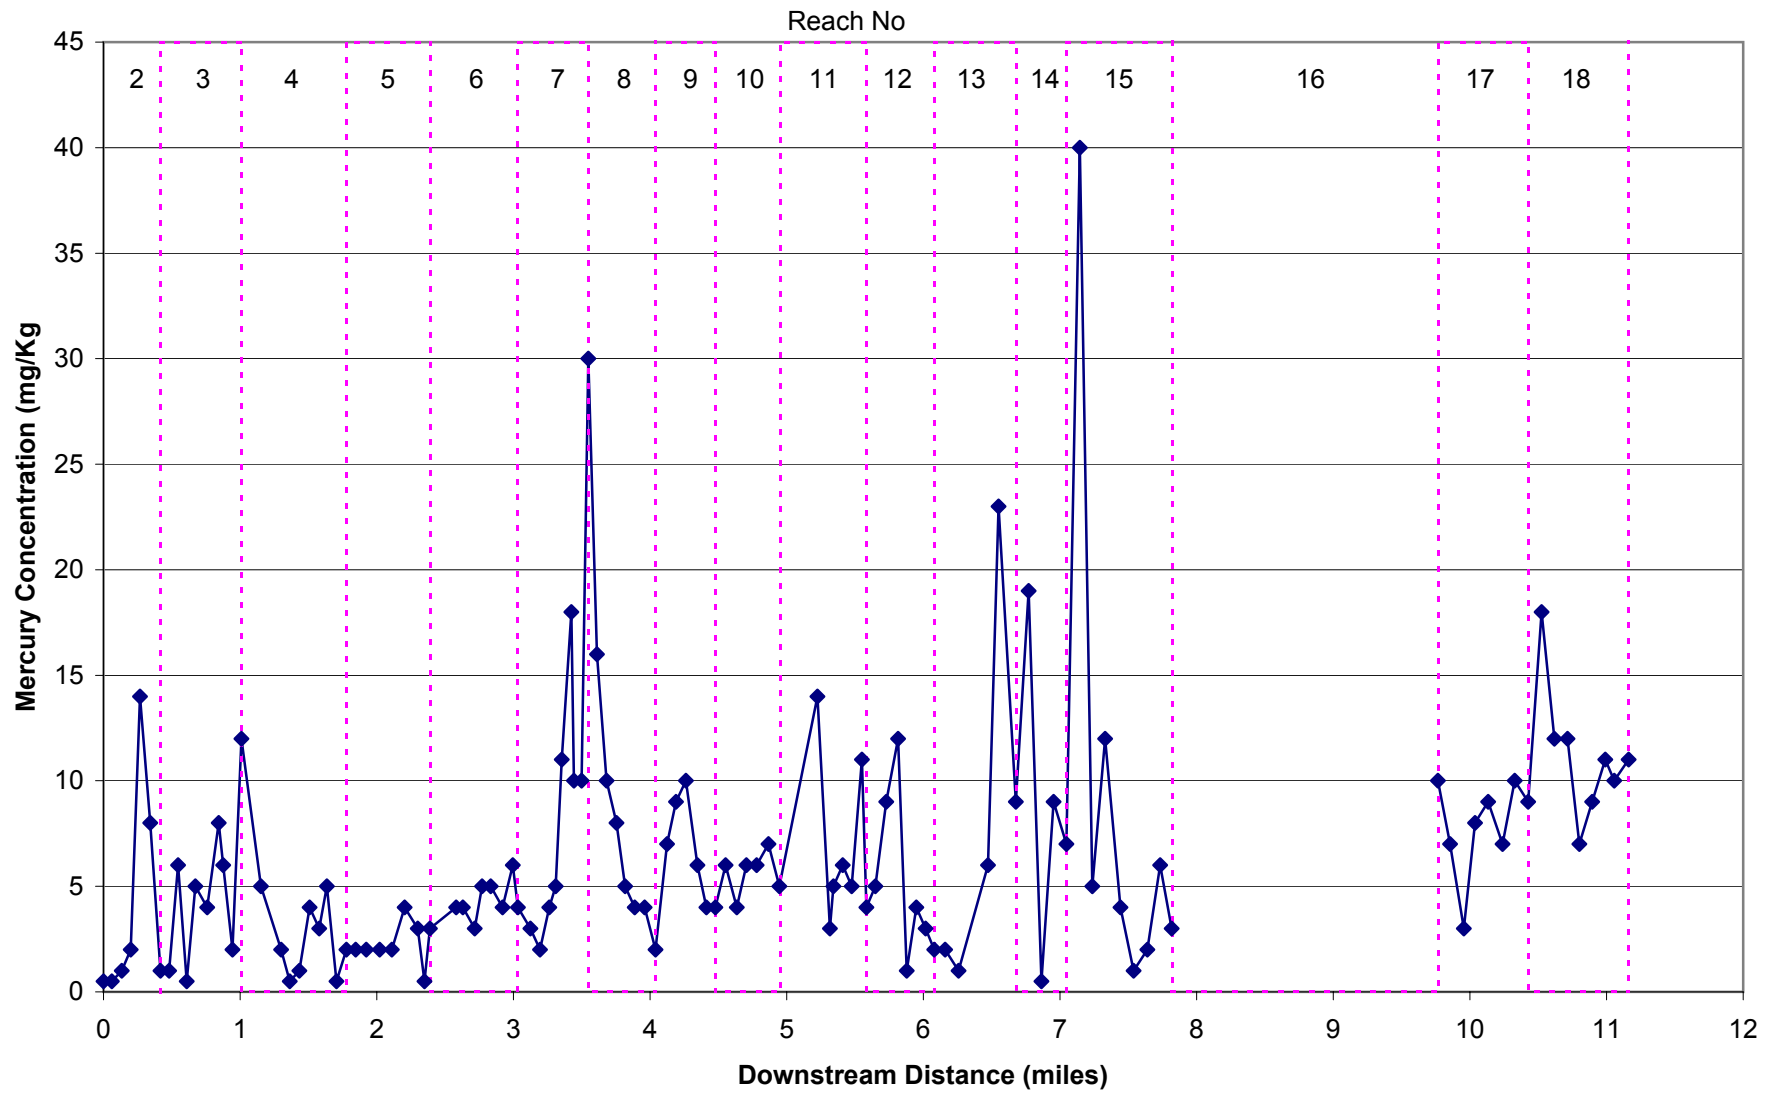
Figure 6-3d. Mercury in Silver Creek Sediments

The following are the laboratory median concentrations for each element analyzed in the stream sediments relative to the mean background concentration: As (0.4 times background or 0.4x), Cu (1.04x), Pb (3.2x), Hg (>8x) and Zn (1.02x). This comparison of stream sediment metal/metalloid concentrations to background indicates that mean arsenic concentrations are significantly less than background, while copper and zinc concentrations are approximately equal to background. Lead and mercury concentrations are elevated relative to background. It should be noted that the background soil concentration of mercury was taken as 0.5 mg/Kg (half of the detection limit) since mercury was not present above the detection limit in of 1 mg/Kg in the background samples. However, background soil samples collected by Pioneer had mercury concentrations ranging from less than 0.03 mg/Kg to 0.187 mg/Kg. Based on these data, the median mercury concentration could be greater than 100 times the times the mean background concentration.
